Document: Cultural Heritage in South-East Europe: KOSOVO - Protection and Conservation of a Multi-Ethnic Heritage in Danger, Mission Report, 26-30 April 2004

Document: “Protection and Preservation of Cultural Heritage in Kosovo - Consolidated Summary”, International Donors Conference organized by UNESCO in cooperation with United Nations Interim Administration Mission in Kosovo (UNMIK), Council of Europe and European Commission, Paris, 13 May 2005

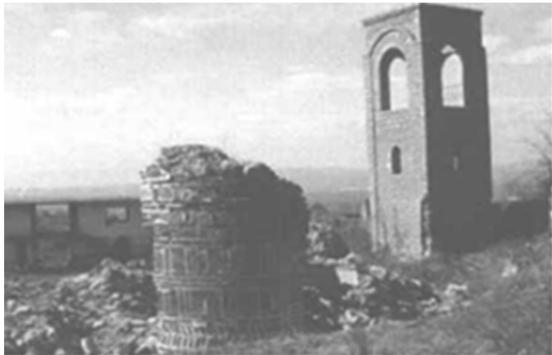
CHURCH OF THE VIRGIN

The church was blown up and the trees cut down. The only parts standing are half of the south apse and the bell tower. The remains are mostly on site and the significant building and fresco fragments are easily recognizable among them.

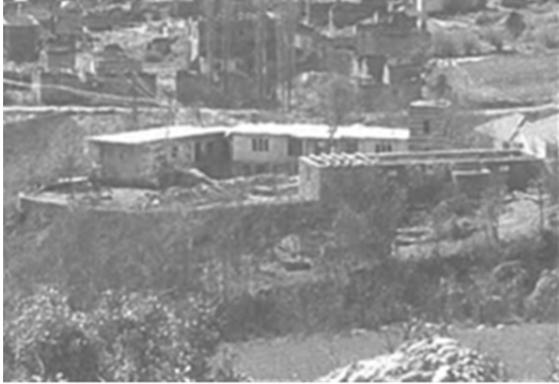
MONASTERY OF THE HOLY HEALERS

Gutted and destroyed. Trees cut down. Only remains and debris can be found in the site of the church. Monastic buildings are partially damaged.

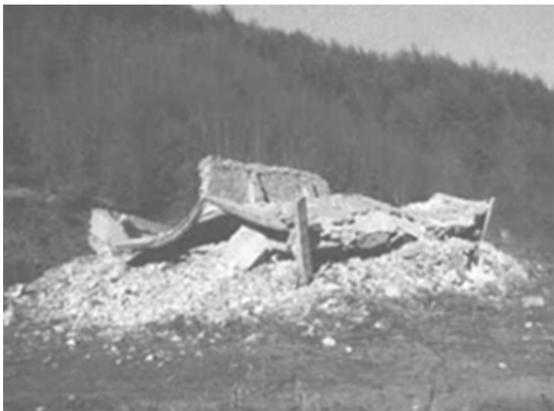
MONASTERY OF ST. UROS

The church was completely blown up in June 1999. The only standing part of the building is the northern wall. There are remains still on site, which do not seem to have been cleared.

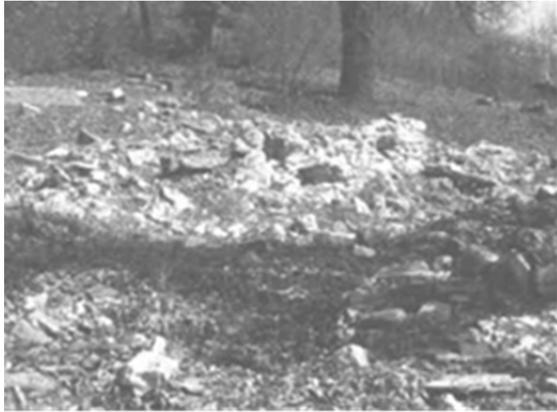
CHURCH OF ST. GEORGE AND CEMETERY

The church is completely destroyed and the rubble has been unprofessionally removed. The cemetery has been systematically vandalized.

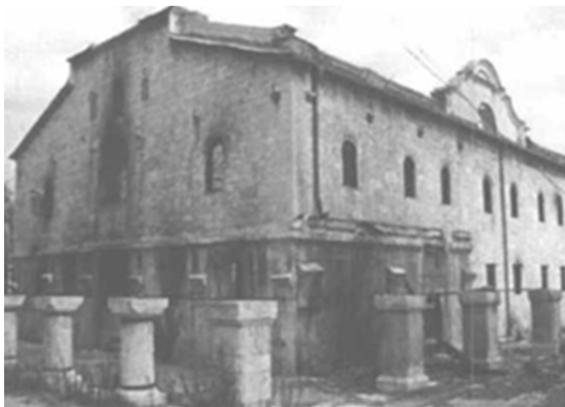
CATHEDRAL CHURCH OF ST. GEORGE

The church was burned down. Only the outer walls and the columns remain standing. The roof, dome, vaults and belfry collapsed and the interior was gutted. Wall paintings, furniture, icons and other treasures are lost.
